Investigation of İstanbul Kartal Example within the scope of urban transformation

Yusuf ÖZ¹, Mehmet Fatih ALTAN¹

Experimental, reserve building area, risky area, risky structures, urban transformation

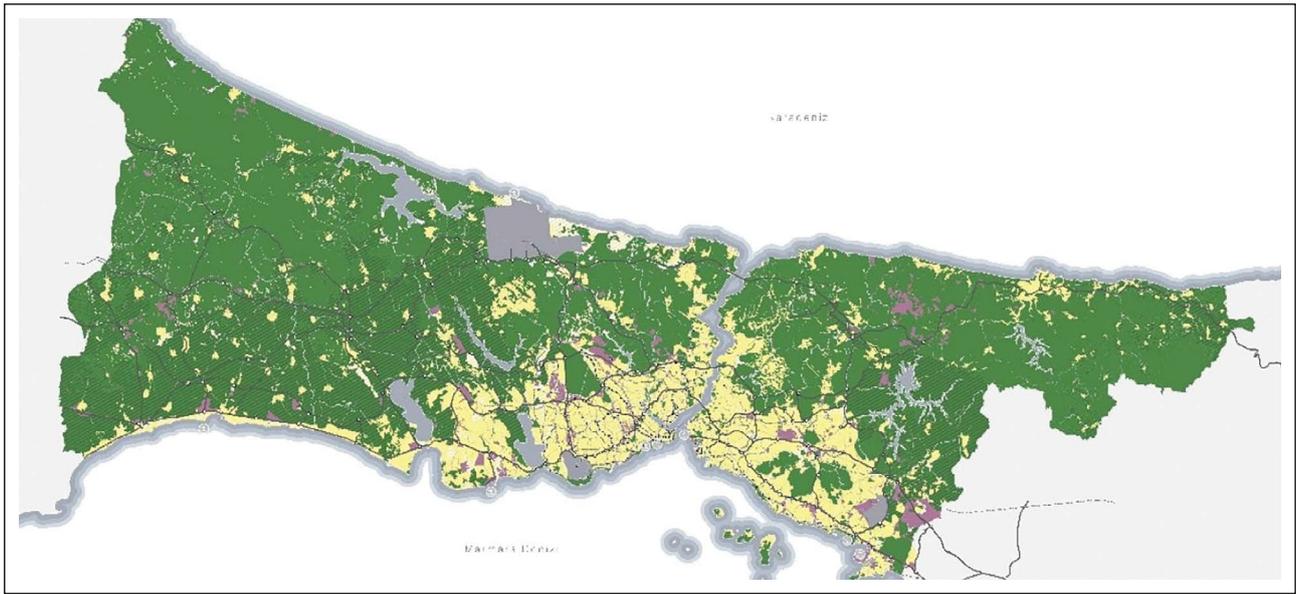
Figure 1. Istanbul's existing urban area.

In Figure 2, the current general structure of Istanbul is shown, yellow areas show urban settlement areas, purple

regions show industrial areas and finally green areas indicate agriculture and green areas. Considering the current structure of Istanbul, the excess of green areas stands out,

and the residential areas are predominantly concentrated in the coastal regions of the Bosphorus overlooking the Marmara Sea.

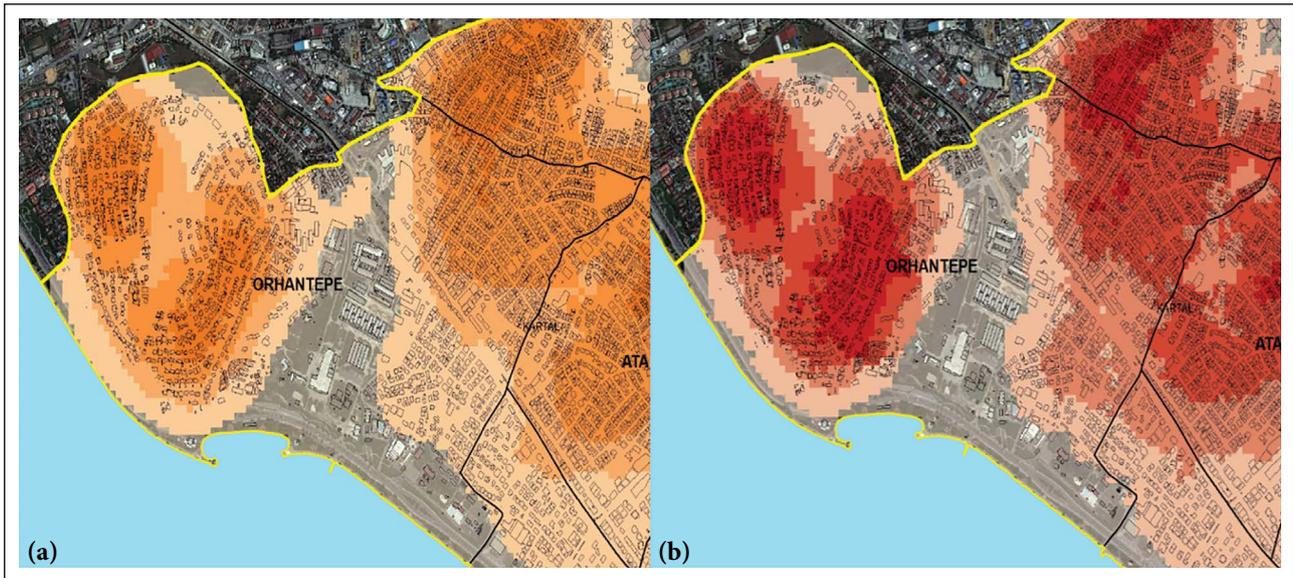
Figure 2. (a) Current structure stock risk distribution. (b) distribution of population at risk.

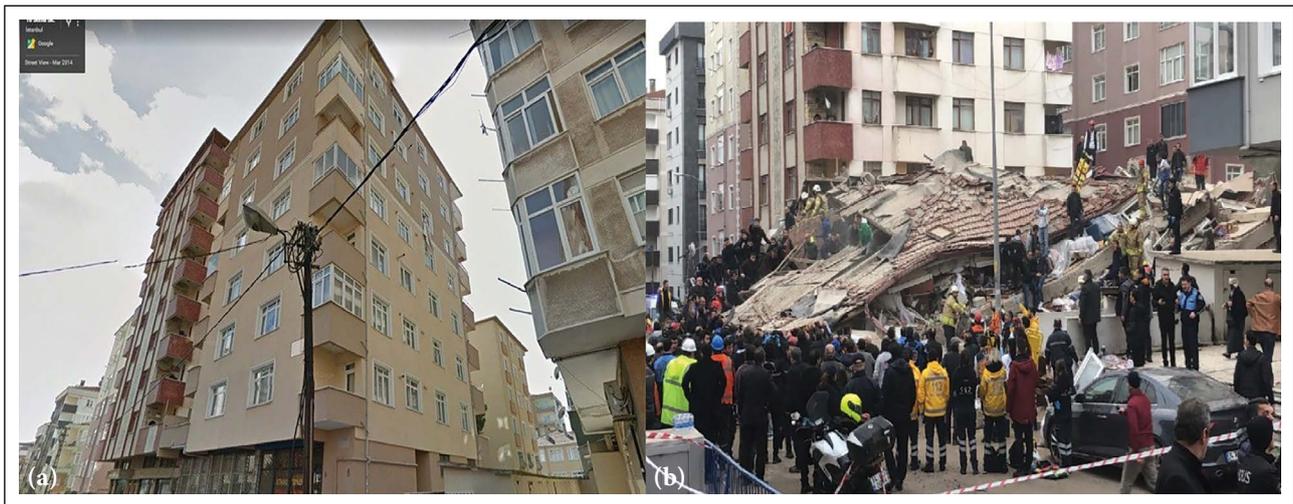
Figure 3. (a) Yeşilyurt Apartments before collapse. (b) Yeşilyurt Apartments after.

The building on the block number 12580 and 101 parcels located in Orhantepe District collapsed at an unexpected date on 06.02.2019 and 21 people died due to dent and 14 people were taken out from the dent. The mentioned structure was built in 1992 with a total of 9 floors, including basement + ground + 7 normal floors. In the license certificate of the building dated 20.10.1992, there is a 7-storey construction permit, including 1 basement floor + ground floor + 5 normal floors. The building was built as 2 floors more in violation of the license given by the relevant administration. Basement and ground floors are used for commercial purposes and other normal floors are used for residential purposes. Basement and ground floors are used for commercial purposes and other normal floors are used for residential purposes. The mentioned structure consists of 14 residences and 3 commercial units. The parcel area is 493 m² and the construction area is 1122 m² according to the current zoning plan. However, the current construction area of the building is 2209 m² with illegal floors.

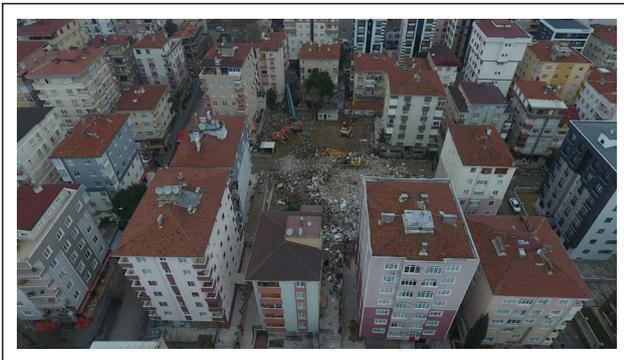
Figure 4. The view after removal of the wreckage of Yeşilyurt Apartment.

After observational determinations from the mentioned structures, drilling core samples were taken within the scope of Law No. 6306 and necessary reinforcement stripping was done. As a result of the examination of the data obtained; It has been determined that the buildings are in a position to endanger the safety of life and property, and that there is intense deformation in the buildings, and accordingly, the buildings located in the mentioned parcels except İhya and Çam Apartments have been declared as “Risky Buildings” within the scope of Law No. 6306. The buildings identified as Risky Buildings were immediately evacuated by the authorities to avoid any danger and demolition of the buildings was carried out.

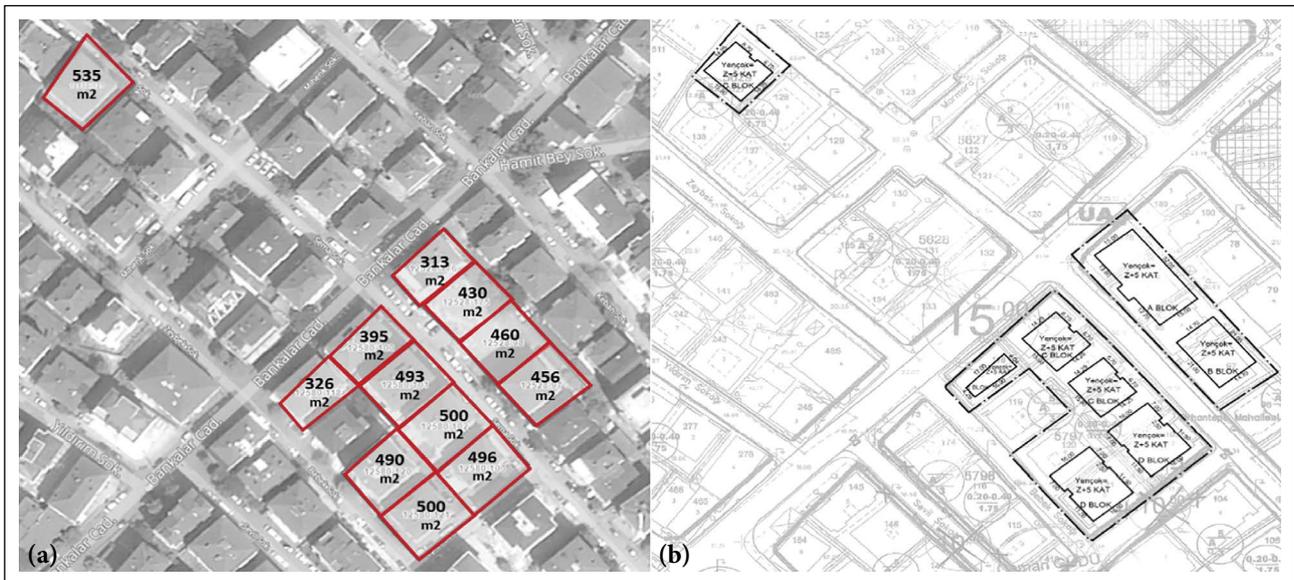
Figure 5. (a) The reserve building area. (b) The reserve building area plan.

The Reserve Building Area was declared on 11.03.2019 within the scope of Law No. 6306, in order to prepare Yeşilyurt Apartments and the surrounding buildings for earthquake risk, and to provide a liveable area for the protection of life and property security. The 1/1000 scale Implementation Development Plan change and plan disclosure report for the mentioned Reserve Structure Area was approved on 14.03.2019.

The buildings within the borders of the Reserve Building Area consist of 129 residences and 29 workplaces. Following the announcement of the Reserve Building Area and the planning processes, the construction process of the construction in the area was started by TOKİ. Along with the mentioned project, 105 houses and 25 workplaces are produced. Approximately 11 months after the date of the incident, 06.02.2019, residences and workplaces were delivered to the beneficiaries on 23.01.2020.
