Evaluation of concrete pavers affected by Manavgat wildfires

Mustafa Altuğ PEKER

Alanya Alaaddin Keykubat University, Antalya, Turkey

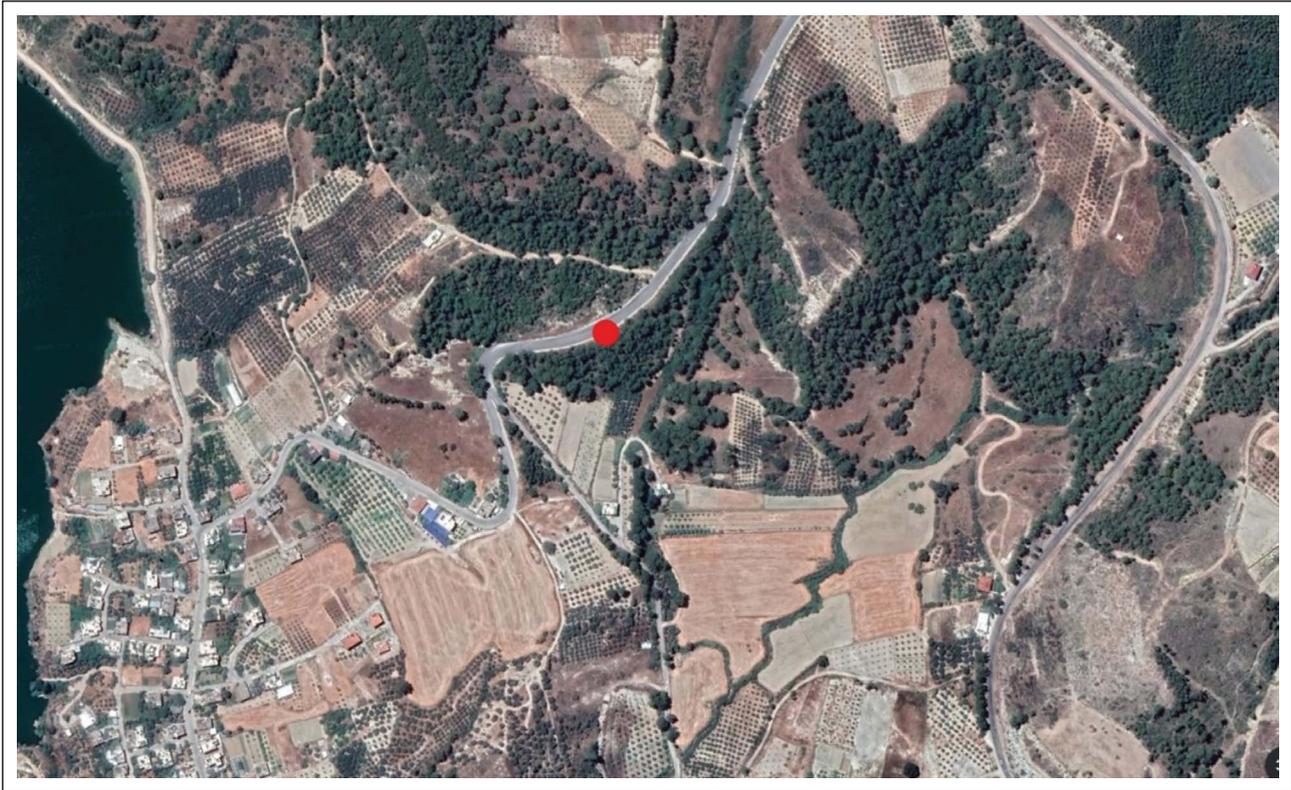
Figure 1. Manavgat-Oymapınar Neighborhood.

In order to obtain the materials in this research, the Manavgat fire area was investigated. The area shown in Figure 1 is the Oymapınar neighborhood. It is clearly seen that this region, where forest and habitats are very close to each other, is WUI.

The field marked red in Figure 1 is the area with the most affected pavement from the fire. It was decided to take the samples from this area. When the paving stones were examined, it was seen that there were completely burned, half-burned and unburned concrete paving stones in the same area. It is planned to take three samples from all three combustion conditions to compare them with each other in terms of the mean value of compressive strength. The pavement affected by the fire is shown in Figure 2.

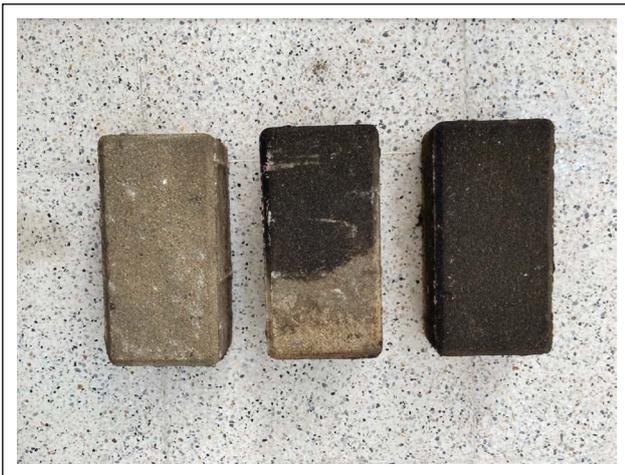
Figure 3. Concrete paving stones in different conditions.

A sample of the completely burned, half-burned and unburned concrete paving stones taken from the Manavgat wildfire area are shown in the Figure 3.

All experiments were successfully completed, and compressive strengths were obtained in accordance with the standard of BS6717 [14, 15]. The compressive strengths measured as a result of the tests are shown in the Table 2. According to the results obtained, the mean value of compressive strengths of unburned, half-burned, and completely burned stones were 36.04 MPa, 49.51 MPa, and 50.83 MPa, respectively.

It is seen that the compressive strength increases as the amount of combustion increases. Normally, the strength of concrete is expected to decrease when exposed to very high temperatures. The reason for the increase in the strength of concrete paving stones may be that the fire went out before it reached a very high temperature on the pavements in the region. A well-known basic fact in thermodynamics, gases have higher temperatures rise up depending on their low density. Increasing in the strengths of the concrete pavers in the burned regions like heat-treated concrete can be explained using this fundamental thermodynamic law. It is also an indication that the fire does not burn the entire pavement and does not spread to the driveway. These results are also consistent with the study [12] in the literature that concretes treated at 250 °C have higher strength than concretes at room temperature.

The results obtained prevent the replacement of paving stones in the region due to strength. However, this result also needs to be evaluated from an architectural point of view. It is clear that the half-burned and completely burned concrete pavers are dirty and have colour mismatch. Therefore, replacement or staining of the stones may be considered.

Before changing the paving stones at the the fire zones, strength tests should be done on the sample and no change should be made unless a negative situation is encountered. In our study, the strength of the concrete increased with burning. Using burnt paving stones with increased strength will be much more convenient than the cost of replacement.

In addition, the cost of painting the fire-affected concrete paving stones is half of the replacement cost when labour and other costs are taken into account. Considering the use of cement in the concrete stones to be used in the renovation process, it is clear that paint will be the most economical and environmentally friendly solution.

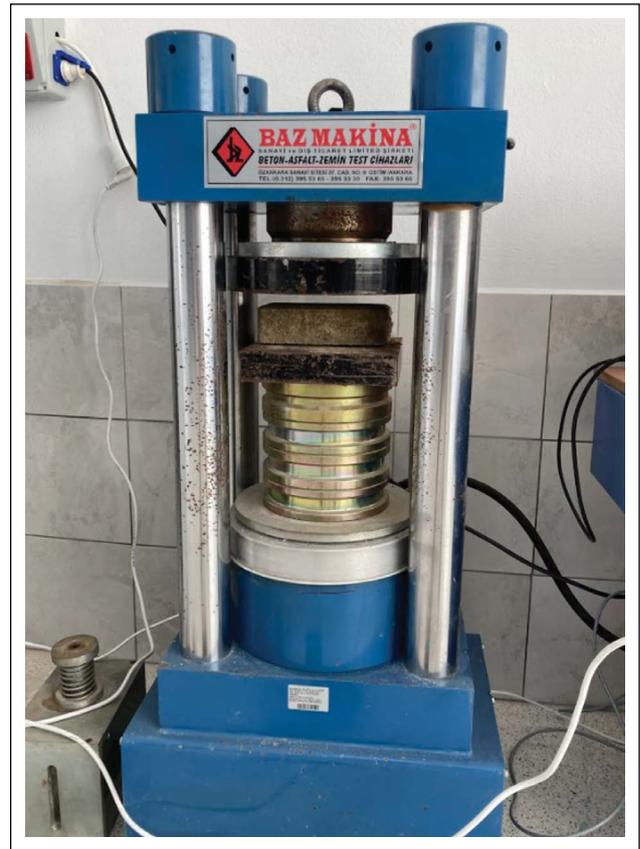
Figure 4. Compression testing machine.

The paving stones were tested in the pressure machine in the Civil Engineering Laboratory of Alanya Alaaddin Keykubat University. The experimental setup is shown in the Figure 4.
