Evaluation of concrete pavers affected by Manavgat wildfires

Mustafa Altuğ PEKER

Alanya Alaaddin Keykubat University, Antalya, Turkey

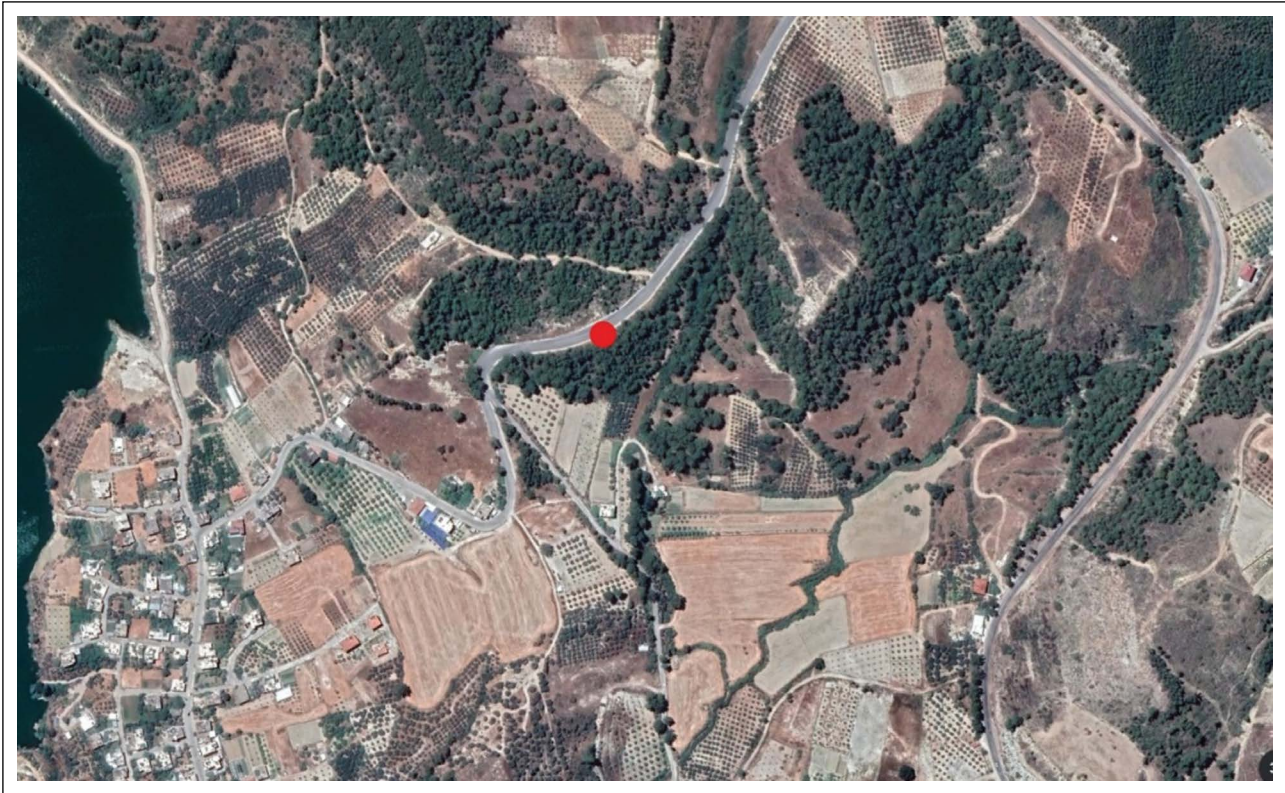
Figure 1. Manavgat-Oymapınar Neighborhood.

In order to obtain the materials in this research, the Manavgat fire area was investigated. The area shown in Figure 1 is the Oymapınar neighborhood. It is clearly seen that this region, where forest and habitats are very close to each other, is WUI.

The field marked red in Figure 1 is the area with the most affected pavement from the fire. It was decided to take the samples from this area. When the paving stones were examined, it was seen that there were completely burned, half-burned and unburned concrete paving stones in the same area. It is planned to take three samples from all three combustion conditions to compare them with each other in terms of the mean value of compressive strength. The pavement affected by the fire is shown in Figure 2.

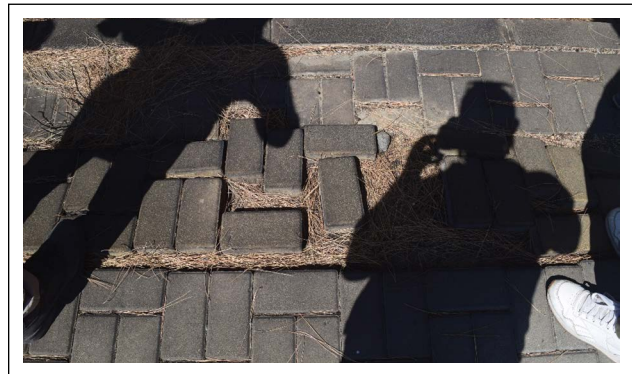
Figure 2. Pavement in the fire zone.

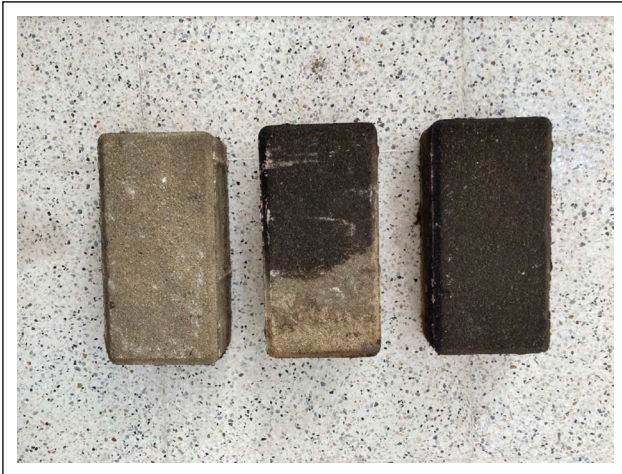
Figure 3. Concrete paving stones in different conditions.

A sample of the completely burned, half-burned and unburned concrete paving stones taken from the Manavgat wildfire area are shown in the Figure 3.

All experiments were successfully completed, and compressive strengths were obtained in accordance with the standard of BS6717 [14, 15]. The compressive strengths measured as a result of the tests are shown in the Table 2. According to the results obtained, the mean value of compressive strengths of unburned, half-burned, and completely burned stones were 36.04 MPa, 49.51 MPa, and 50.83 MPa, respectively.

It is seen that the compressive strength increases as the amount of combustion increases. Normally, the strength of concrete is expected to decrease when exposed to very high temperatures. The reason for the increase in the strength of concrete paving stones may be that the fire went out before it reached a very high temperature on the pavements in the region. A well-known basic fact in thermodynamics, gases have higher temperatures rise up depending on their low density. Increasing in the strengths of the concrete pavers in the burned regions like heat-treated concrete can be explained using this fundamental thermodynamic law. It is also an indication that the fire does not burn the entire pavement and does not spread to the driveway. These results are also consistent with the study [12] in the literature that concretes treated at 250 °C have higher strength than concretes at room temperature.

The results obtained prevent the replacement of paving stones in the region due to strength. However, this result also needs to be evaluated from an architectural point of view. It is clear that the half-burned and completely burned concrete pavers are dirty and have colour mismatch. Therefore, replacement or staining of the stones may be considered.

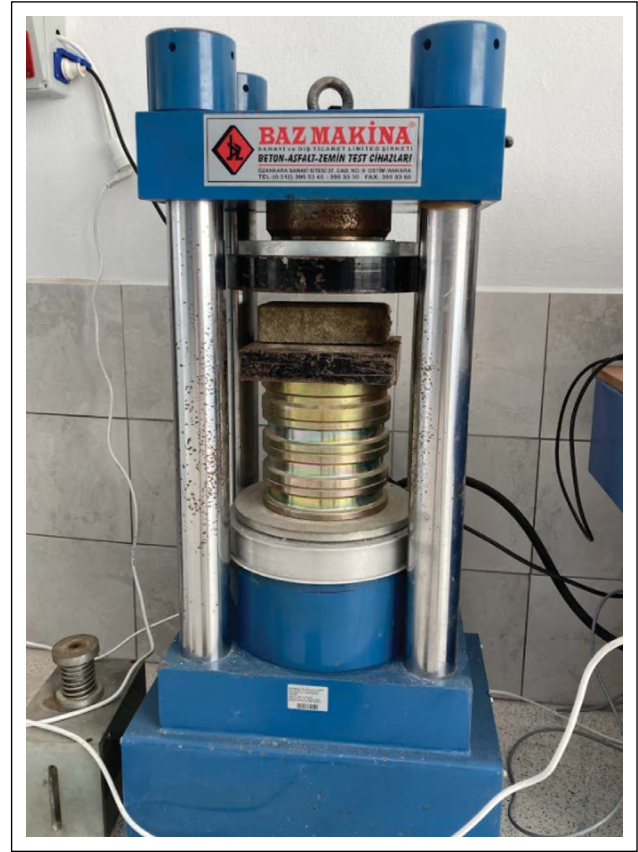
The paving stones were tested in the pressure machine in the Civil Engineering Laboratory of Alanya Alaaddin Keykubat University. The experimental setup is shown in the Figure 4.

Figure 4. Compression testing machine.
